Capsule Summary  
SM-666  
Turkey Cock Hill Tenant House  
Leonardtown vicinity  
Private

c. 1900

## SM-666, Turkey Cock Hill Tenant House

# Photo Documentation

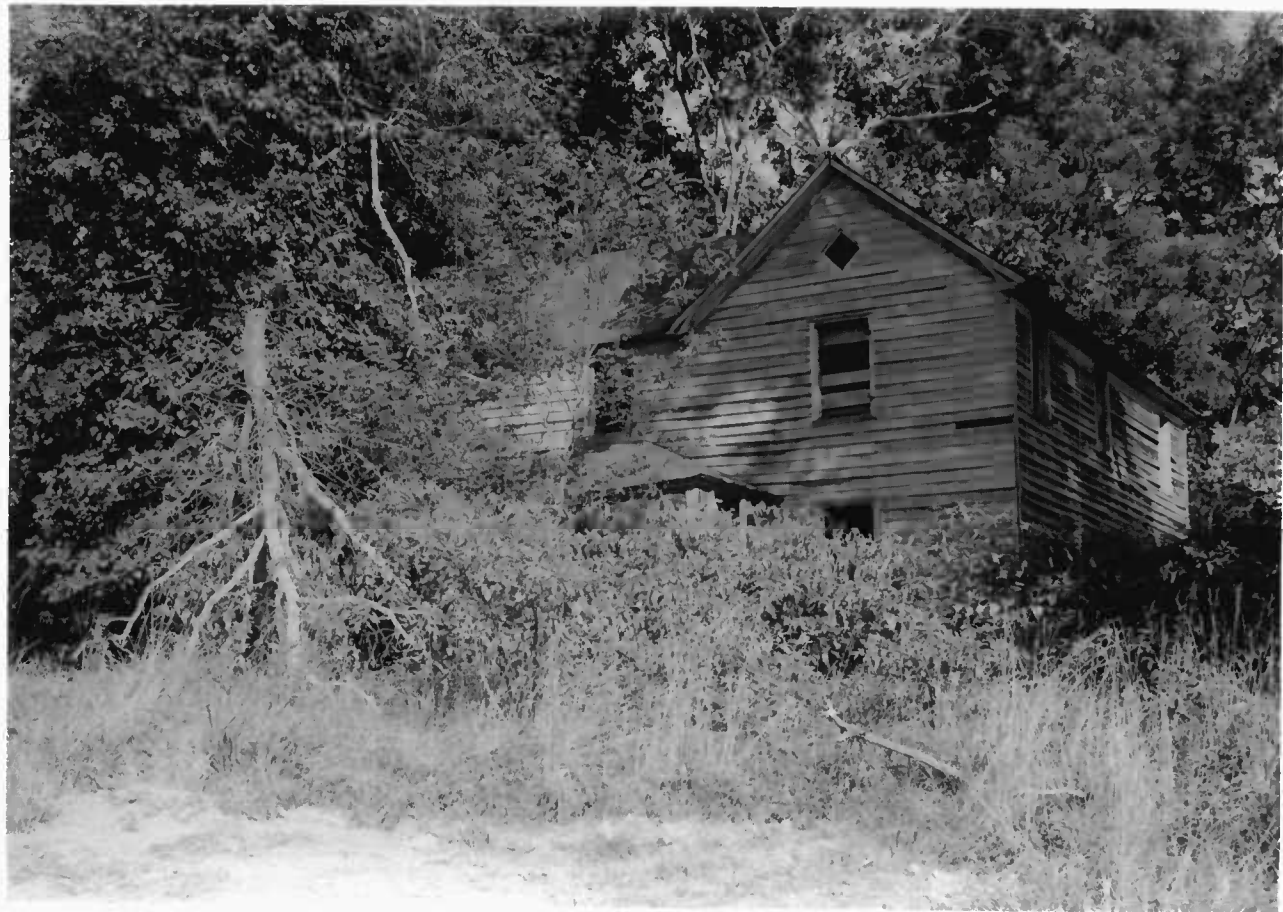
1 of 2

W + S elevation

The primary or west elevation's bays are symmetrically arranged and consist of a centrally located panelled door flanked on either side by a two-over-two, double-hung sash window (All windows in the house are two-over-two windows unless otherwise noted and almost all have been broken out.). Only the door is shaded by a porch that is supported by square posts once decorated with scroll sawn brackets. The second floor is pierced by three two-over-two windows. Above the southernmost window is a diamond-shaped pane that is no longer extant. An interior end, brick chimney flue is located on the north side of the elevation.

The south elevation's fenestration is composed of two windows on the first floor and three windows on the second floor. A brick chimney flue projects from the center of the roof.

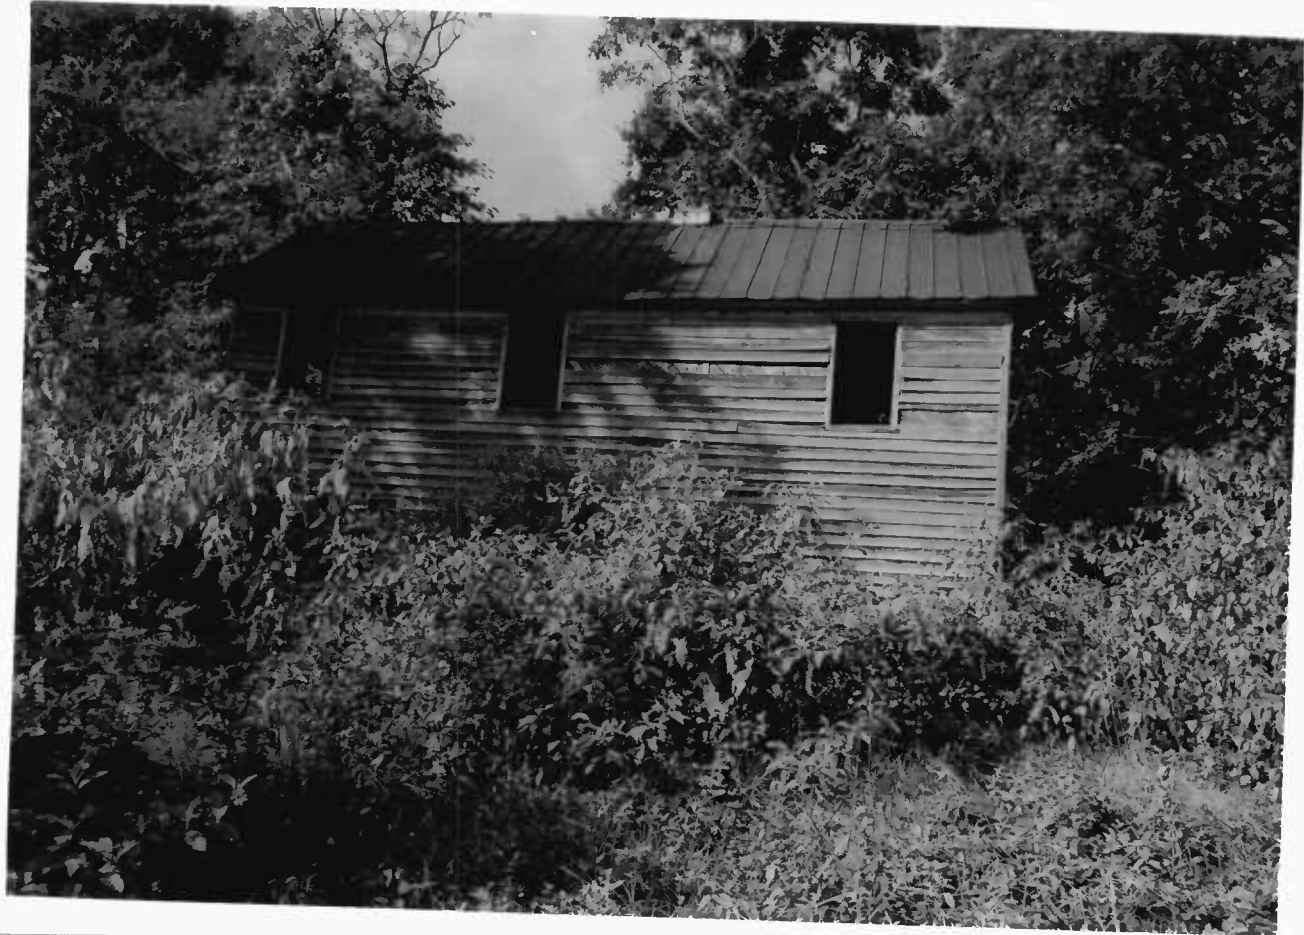
2 of 6

Elevation

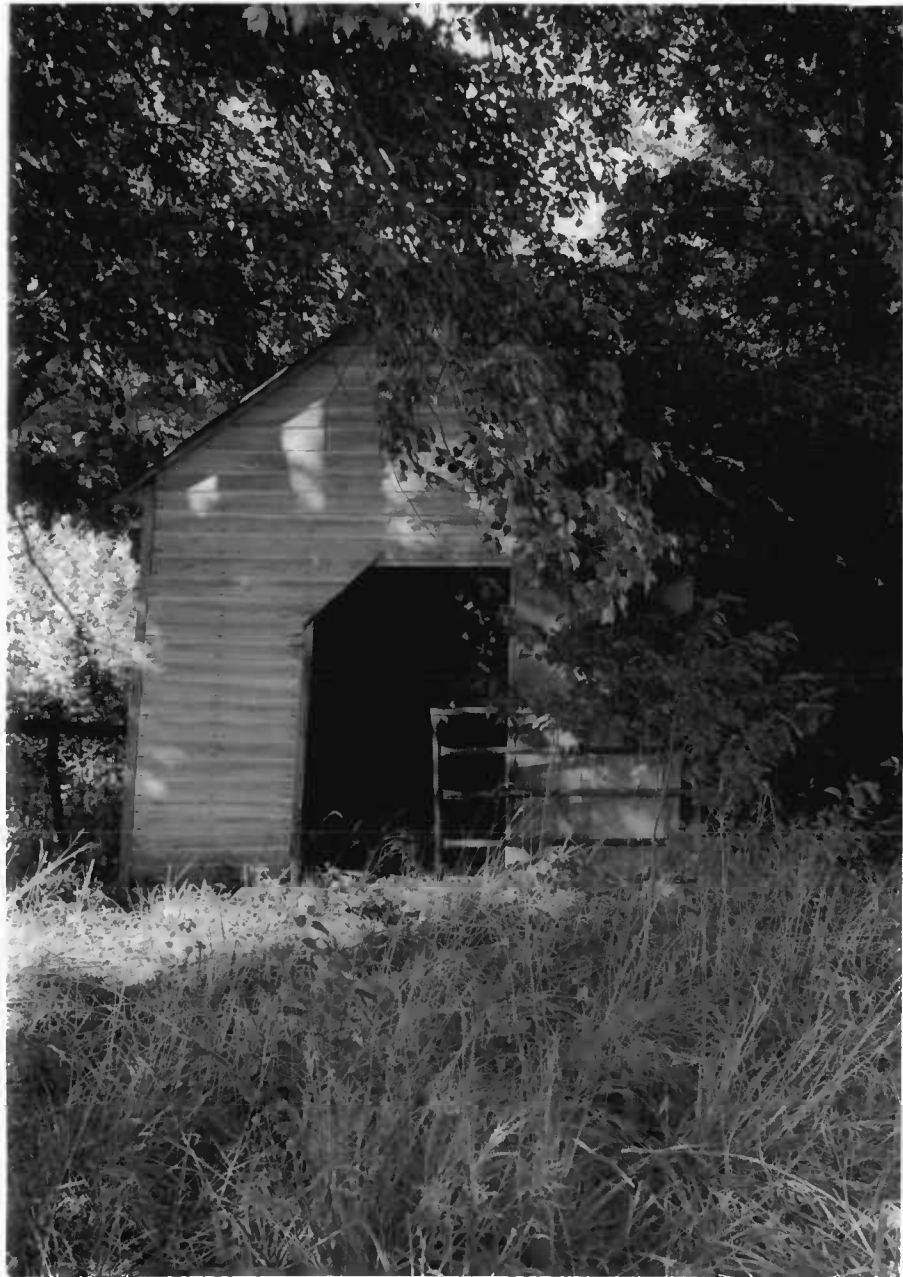
1 of 6

garage - 3 elevations
